DEPARTMENT OF TRANSPORTATION

Contract #: 04-0120F4Cty: SF/ALA Rte: 80 PM: 13.2/13.9File #: 69.28**WELDING INSPECTION REPORT****Resident Engineer:**Pursell, Gary**Address:** 333 Burma Road**City:** Oakland, CA 94607**Report No:** WIR-016366**Date Inspected:** 13-Aug-2010**Project Name:** SAS Superstructure**OSM Arrival Time:** 700**Prime Contractor:** American Bridge/Fluor Enterprises, a JV**OSM Departure Time:** 1900**Contractor:** Zhenhua Port Machinery Company, Ltd (ZPMC), Changxing Island **Location:** Shanghai, China**CWI Name:** Qiu Wen**CWI Present:** Yes No**Inspected CWI report:** Yes No N/A**Rod Oven in Use:** Yes No N/A**Electrode to specification:** Yes No N/A**Weld Procedures Followed:** Yes No N/A**Qualified Welders:** Yes No N/A**Verified Joint Fit-up:** Yes No N/A**Approved Drawings:** Yes No N/A**Approved WPS:** Yes No N/A**Delayed / Cancelled:** Yes No N/A**Bridge No:** 34-0006**Component:** Tower & OBG Components**Summary of Items Observed:**

WELDING INSPECTION REPORT

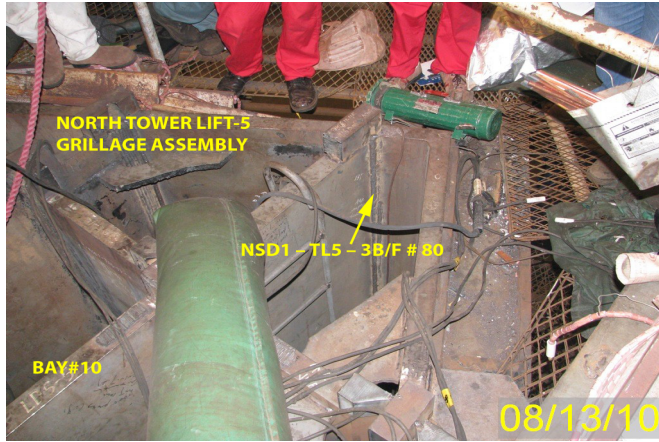
Weld joint # 10 located on South tower Lift-5 Grillage Assembly SSD1 – TL5 – 1B/F. Welder is identified as 050289. ZPMC Quality Control (QC) Inspector is identified as Li Peng Fei. The welding variables recorded by QC appeared to comply with the WPS – B – T – 3213 – TC – U4c.

Weld joint # 80 located on South tower Lift-5 Grillage Assembly NSD1 – TL5 – 3B/F. Welder is identified as 066443. ZPMC Quality Control (QC) Inspector is identified as Li Peng Fei. The welding variables recorded by QC appeared to comply with the WPS – B – T – 3213 – TC – U5b.

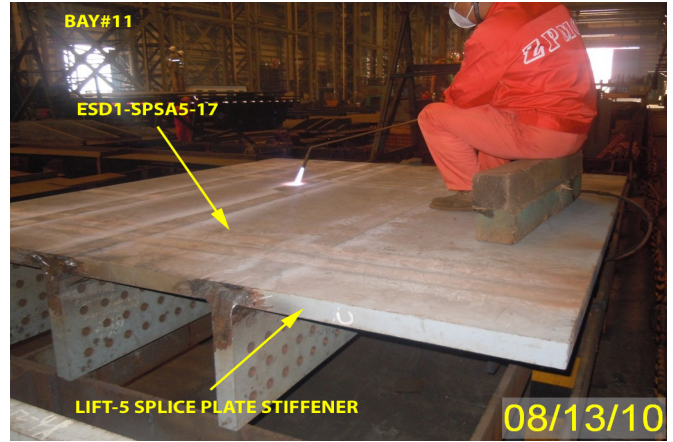
Heat Straightening being performed on Tower Lift-5 splice plate stiffener identified as ESD1-SPSA5-17 by oxy-acetylene flame method to remove the distortion that occurred after welding. ZPMC Quality Control (QC) Inspector is identified as Liu Dao Feng present at the location. This activity appeared to comply with the Heat Straightening Report # HSR1 (T) – 11496. (See attached photo)
